**ADDENDUM TO
EROSION HAZARD ZONE
DELINEATION
AUSTIN OAKS PUD**

August 15, 2016

AUSTIN OAKS PUD

EROSION HAZARD ZONE

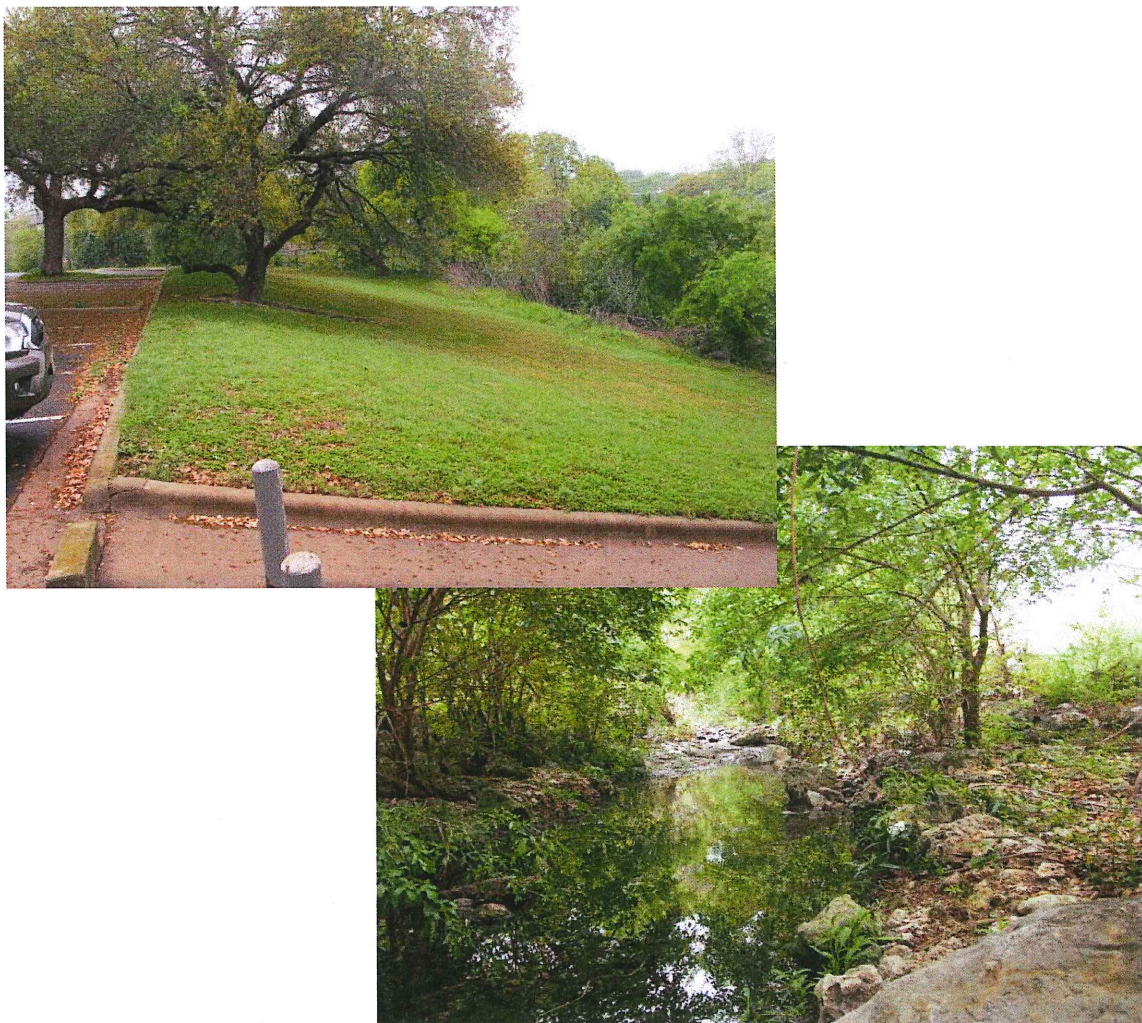
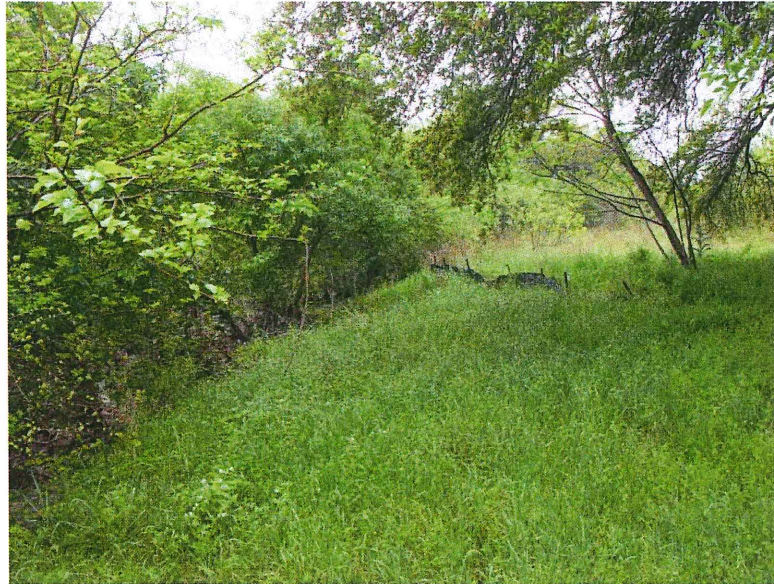
The channel in the Foster Branch reach is characterized by a stable rock (limestone) invert and stable vegetated sloping banks extending to Spicewood Springs Road on the north and to an existing parking lot on the south. This condition is illustrated in the images below.

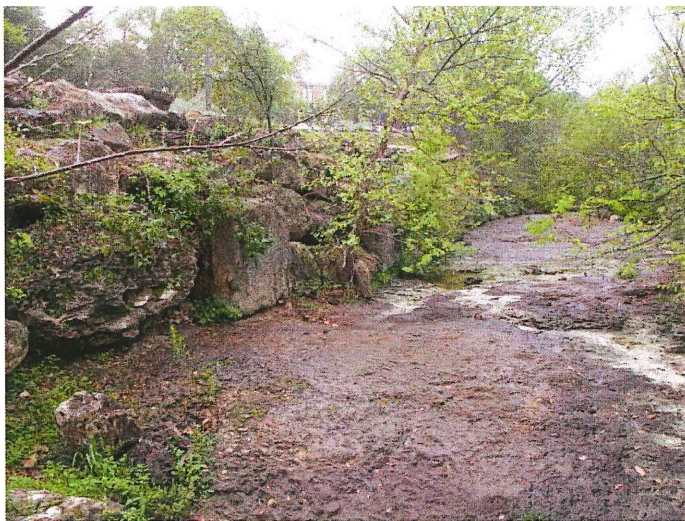
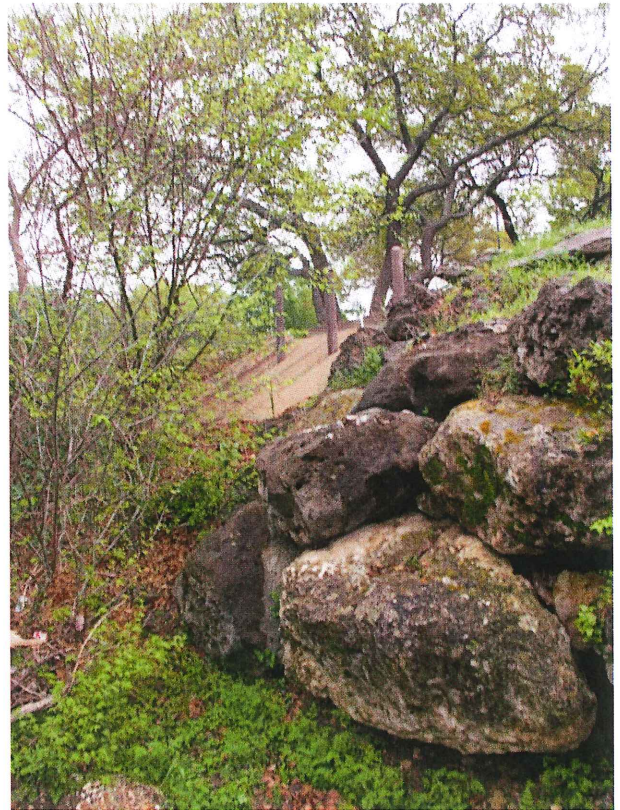
The channel in the lower Wood Hollow reach is characterized by a stable rock (limestone) invert approximately 20 feet wide with steep banks constructed by placement of large boulders. This condition is illustrated in the images below.

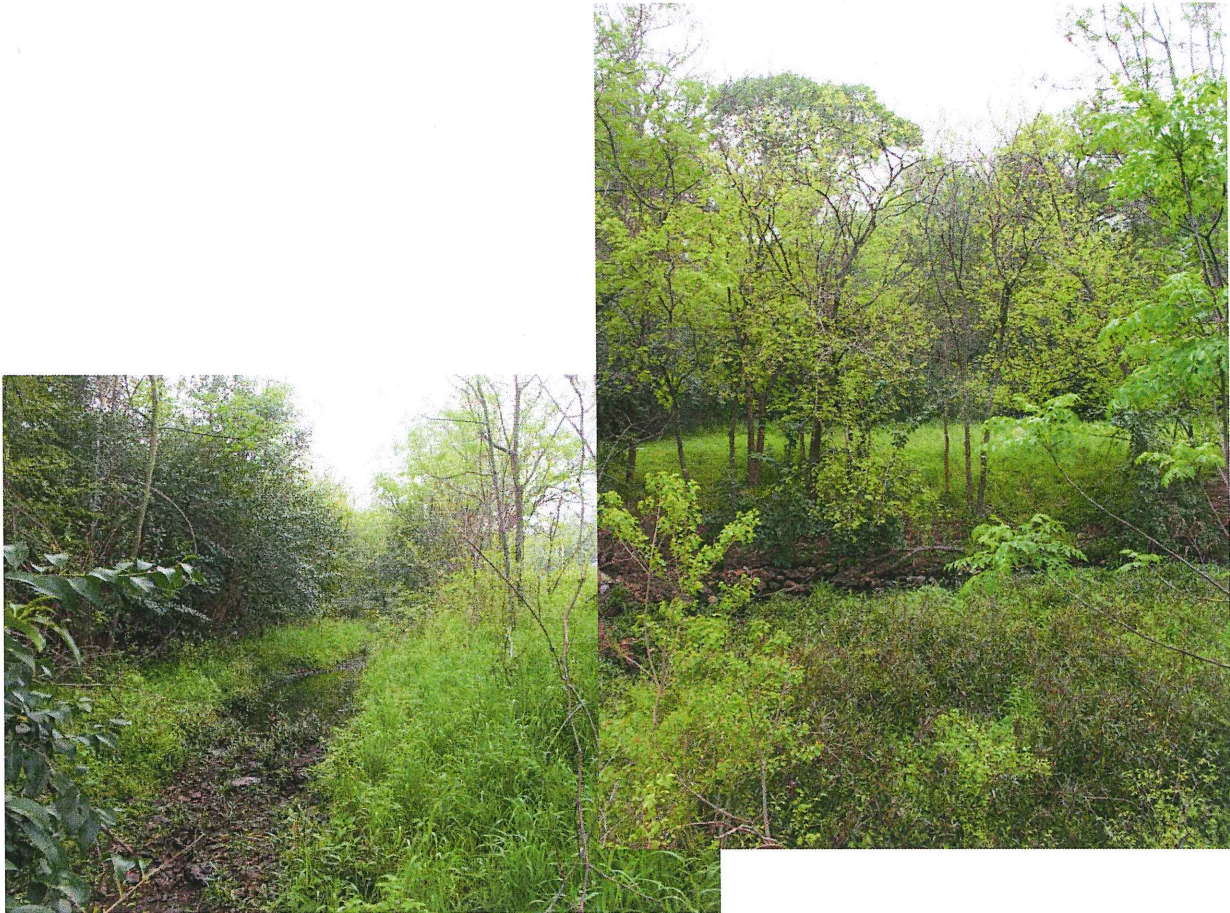
The channel in the upper WHR, upstream of Executive Center Drive, is characterized by a stable rock (limestone) invert and stable vegetated sloping banks extending to Wood Hollow Drive to the west and to the retaining structure for the existing development on the east.
